An exploration of the Ashdown Forest Centre Barns

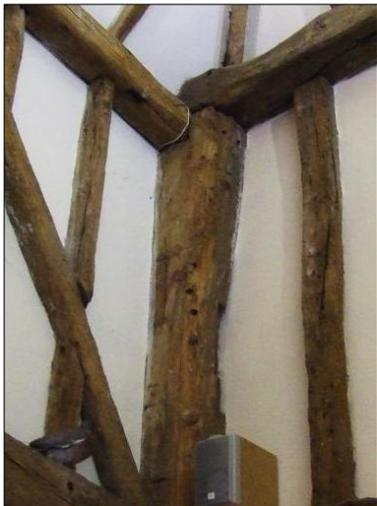
complex jointing needed. There are examples of scarfing, where two beams are cut with a step at the end so that they can be joined together to run a longer distance.

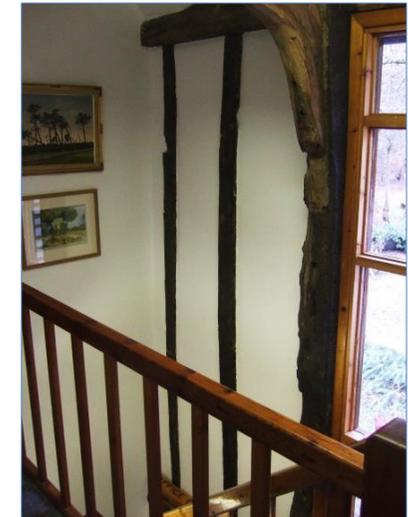
The Admin Barn, four/five bays, is probably older. Wind-bracing in the roof to prevent it racking - straining out of shape - and other pointers, suggest a date between 1650 and 1700. Of great interest is the close-studding – the upright timbers which can be seen beside the stairs. These run the full height of the building, a distinctively Kentish or at least eastern Wealden feature. At the western end, the tie beam across the roof space has been carefully prepared to fit into a supporting upright beam, but this is no longer present. The barn in its current form has a mixture of braces, original curved ones in some parts, but where these would have impeded the building's current use as offices, they have been replaced by knee braces, essentially bits of tree which have grown into a conveniently right-angled shape, just one example of repairs and alterations made to both barns over the years.
