The Barns at the Ashdown Forest Centre

Pam Griffiths

The present booklet is about the origins of the barns at the Ashdown Forest Centre. It is written by Pam Griffiths and draws on research commissioned from the group by the Conservators of Ashdown Forest who wished to know more about the provenance of the three buildings – the Education Barn, Information Barn and the Administration Barn – that were erected at Wych Cross in the early 1980s. These barns were the new base for the conservators, their offices having previously been located in Forest Row, but while it was obvious that the barns were old, little was known about them. The research carried out by Pam, with the invaluable help of Dr Annabelle Hughes, an expert in Wealden timber-framed buildings, has shed new light on these historic buildings.

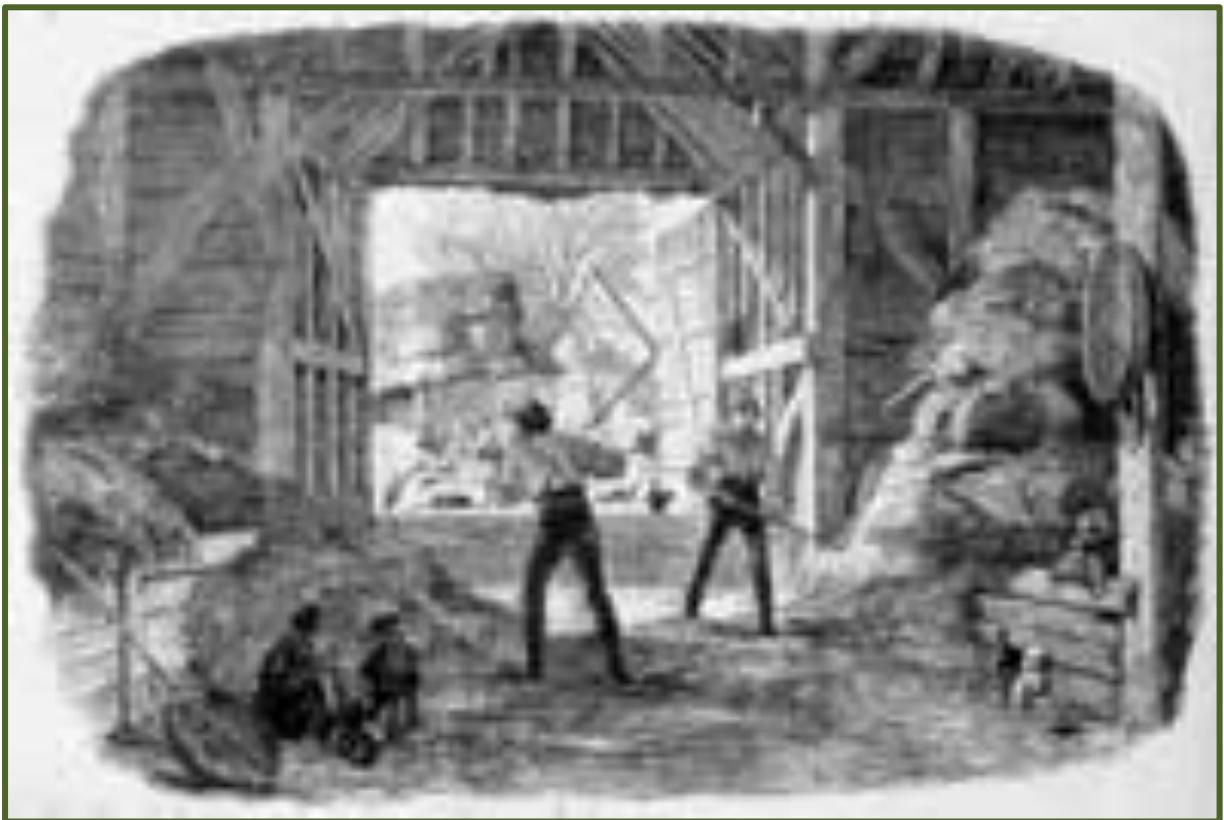
Photographic copy of an engraving of a threshing barn, 19th century From MS 823/1/4/39 (<https://www.nottingham.ac.uk>)

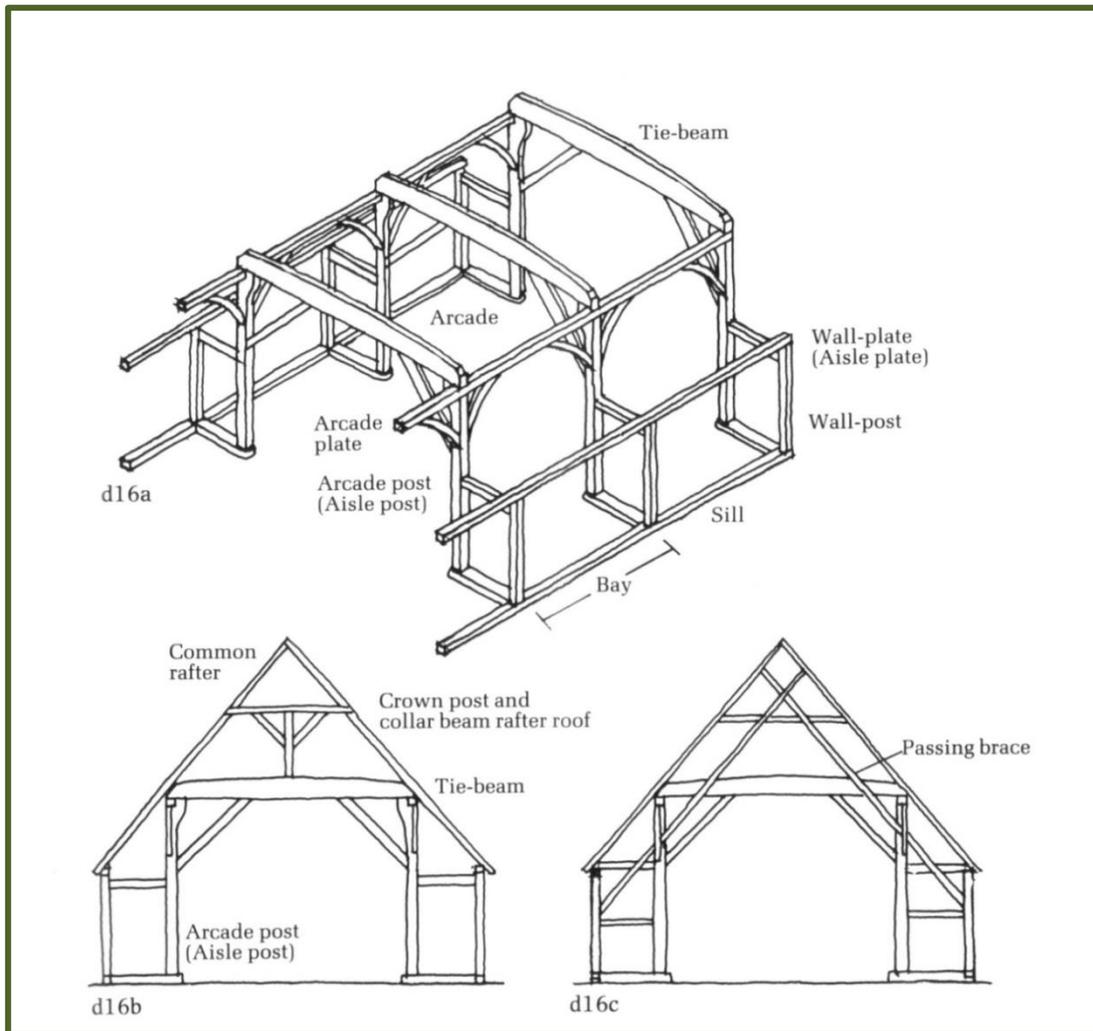
Illustration from Timber Building in Britain R W Brunskill

Box frames, like the ones at the Forest Centre, were the flat-packs of the day, constructed off-site as individual bays and then erected in situ. These were pegged and then strengthened by braces between the posts and tie beams across the space. Once the roof was on, upright posts from the tie beam to the collar beam were further rigidified by braces, creating elegant crown posts in the roof.

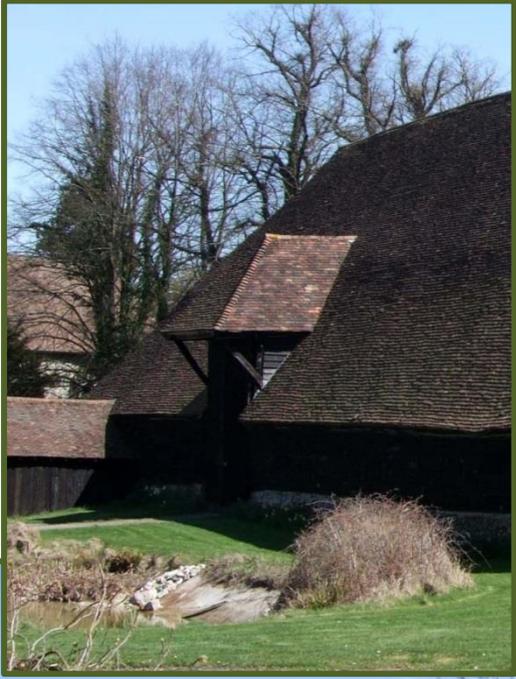
The bay of the barn which contained the threshing floor was called the **midstrey**. There was often a room built in above this – at Lenham it is over the church end porch. This presumably was for the ‘security guard’ employed to deter thieves.

The barn at Lenham also has a hipped roof of pegged, clay tiles. A close look at the roof shows where the angle changes marginally where the arcade plates for the aisles are positioned.

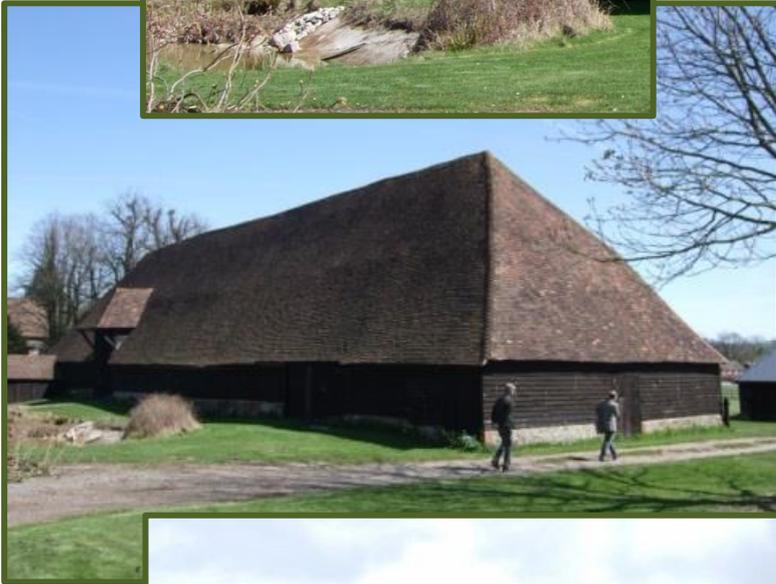
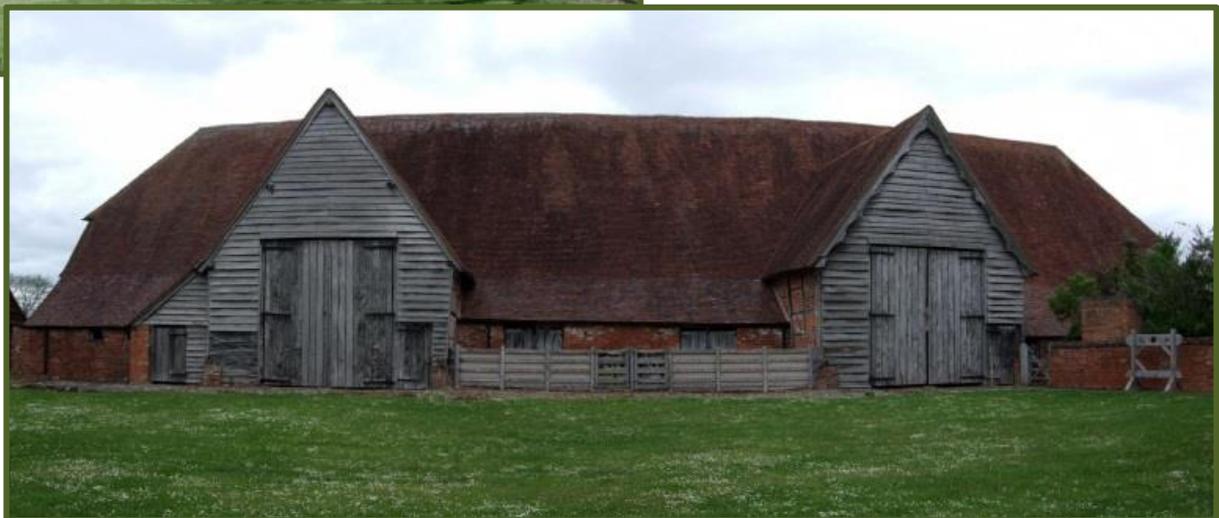
Other parts of the country favoured cruck-framed buildings, such as at Leigh Court in Gloucestershire.

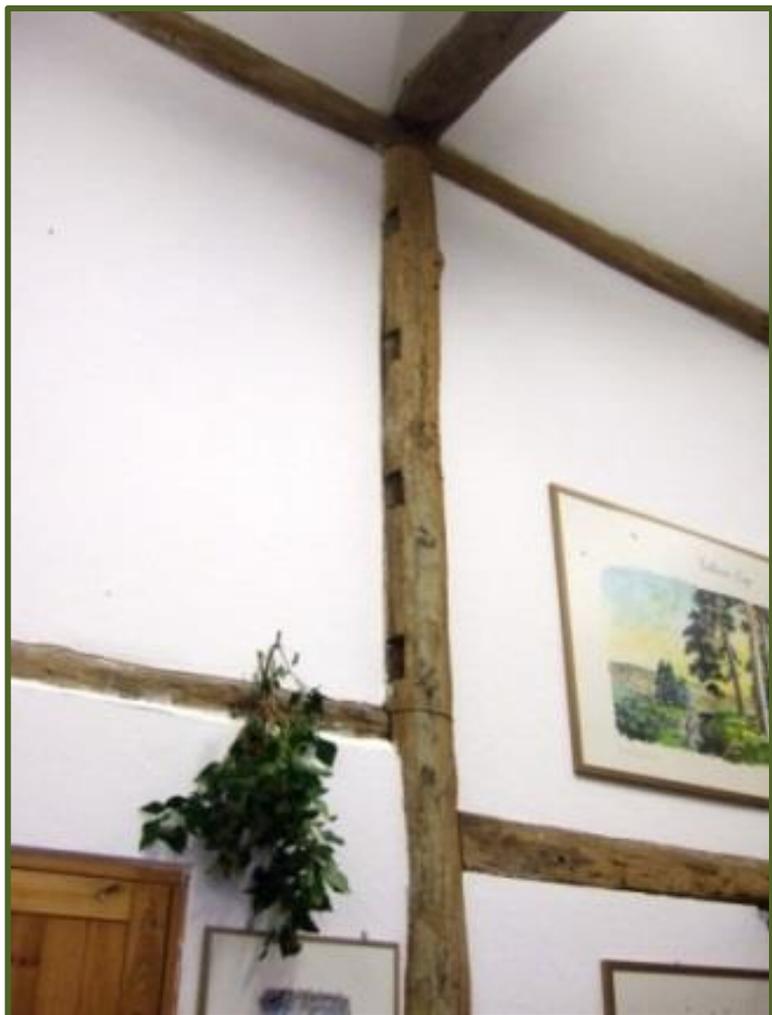
The **Education Barn** seems to have been constructed from recycled wood from other barns. A close look at the timbers shows empty mortice joints, birdsmouths on vertical timbers instead of horizontals, where they should support rafters, and weathering on internal beams.

The Education Barn's half-hipped roof, long run of tiling, and weatherboarding are all authentic features. Nevertheless, this building is a construct, made of a mixture of timbers from different buildings.

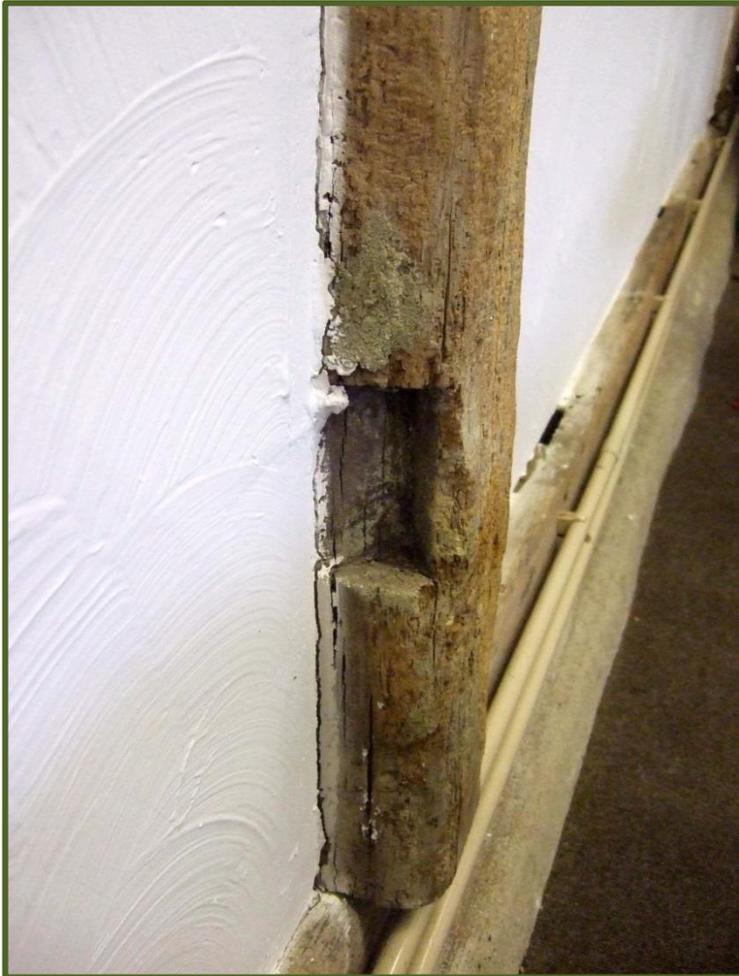
This shows a **birds-mouth** (so called as the shape looks like a baby bird's open beak) as it appears in the Education Barn – on a *vertical* post.

- **Mortices** carved into beams didn't match up and had no braces in them
- Weathering was evident on internal posts
- A **lateral eaves beam** with **birdsmouths** was being used as a vertical upright
- The **roof braces** were too small and the holes in the **tie braces** weren't being used as intended
- There are **queen posts** supporting roof timbers in some bays but not others

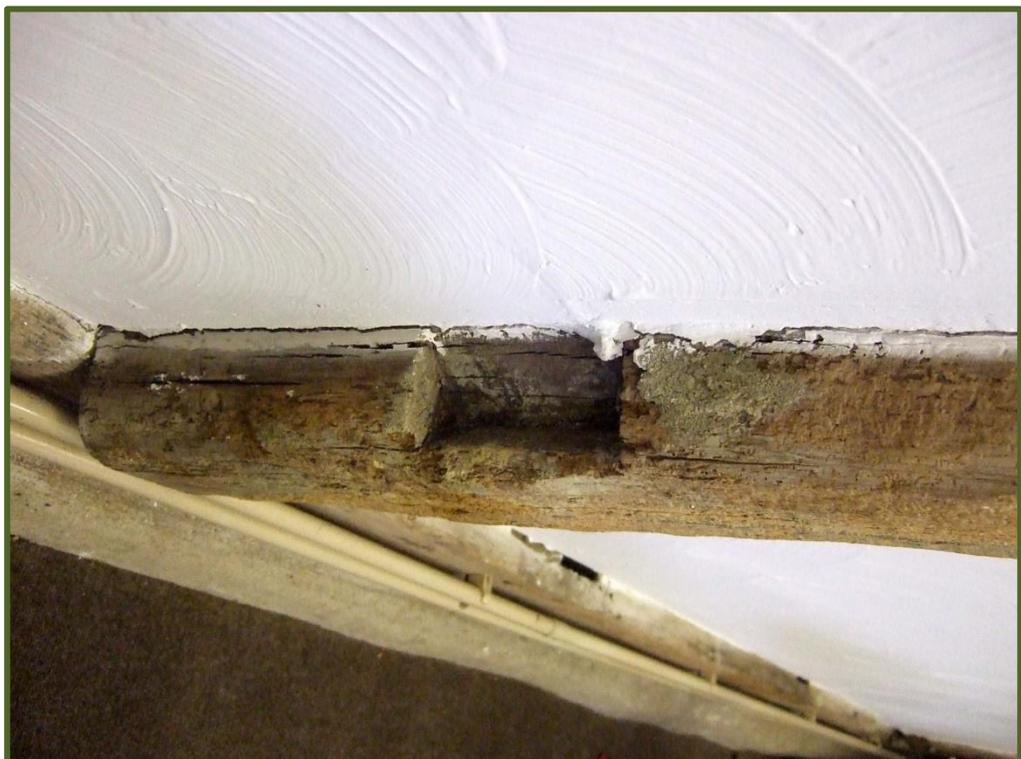
Below is roughly how it should be positioned – as a horizontal V-shaped slot designed to support a rafter.

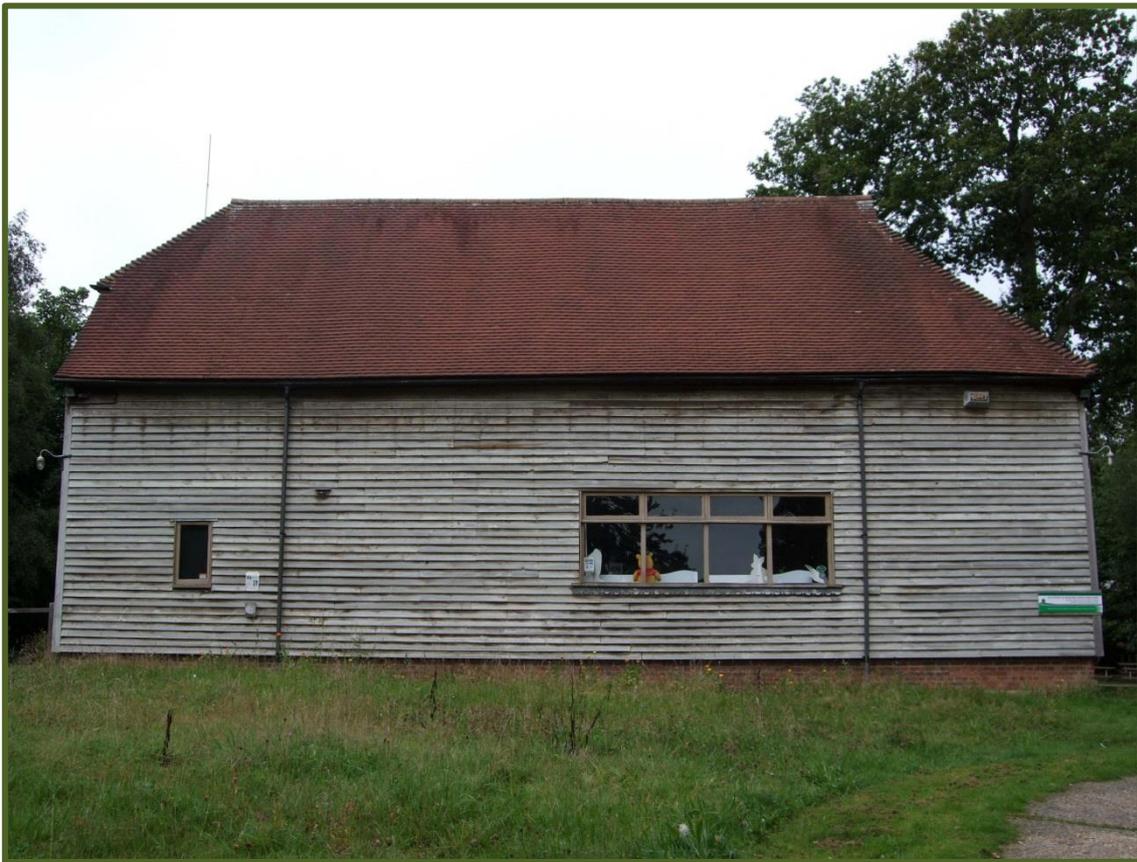
From the outside, the Information Barn looks similar in style to the Education barn, but this is the genuine article, although a large window has been set in place of the original threshing doors. If there had originally been a fifth bay, they would have been in the centre, as was the norm.

- The proportions are in keeping with being a **Wealden** barn
- **Mortices** on the vertical beams either side of the window are on the window side; braces were fitted on the edge closest to the door.
- The **braces** are substantial, and fit in the mortices made for them in most cases, though some are missing at the far end.
- The **queen posts** are consistent with the rest of the barn
- There are **butt purlins**, i.e. horizontal longitudinal beams in the roof. These are very slightly staggered to avoid all the pressure coming on one point of the rafters. This staggering became more intensified over the years which helps date the barn.
- The **eaves plates** have been scarfed at each point where two timbers join.

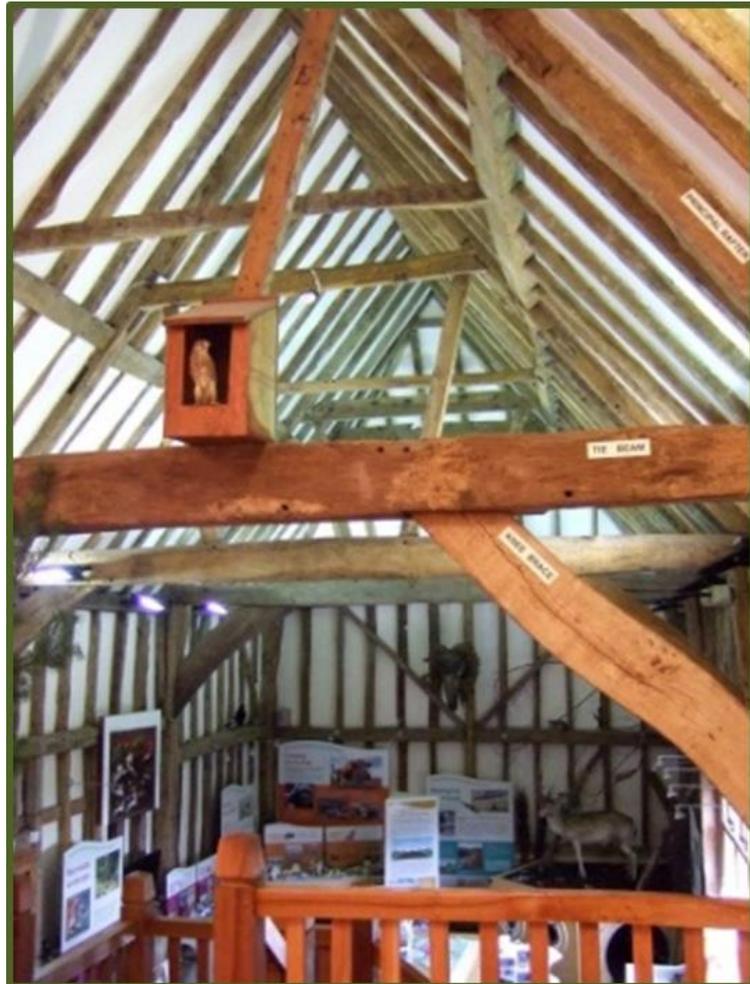
The Information Barn is probably from Sussex originally. Now sporting four bays, there may have originally been a fifth, making it a high status threshing barn, belonging to a farm of at least 100 acres. Several features, e.g. the lack of a ridge board along the apex of the roof and the pegged rafters, suggest a date between 1650 and 1750.

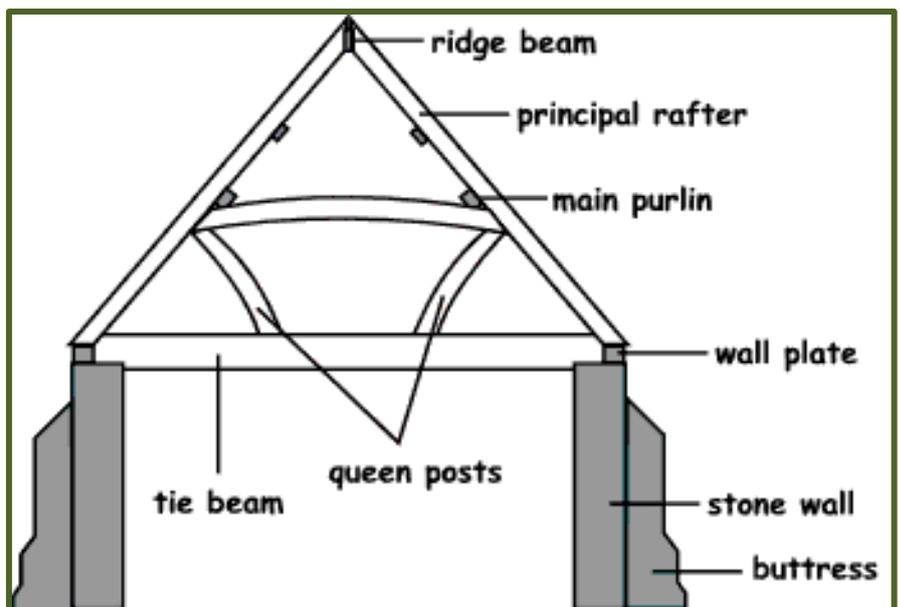
Another feature of the Information Barn is the **Queen Posts** holding the tie beam to the rafters; the example shown is from the roof of Salisbury Cathedral, but the principle is the same – two uprights rising from the tie beam to the collar beam, making a shape not unlike the π symbol.

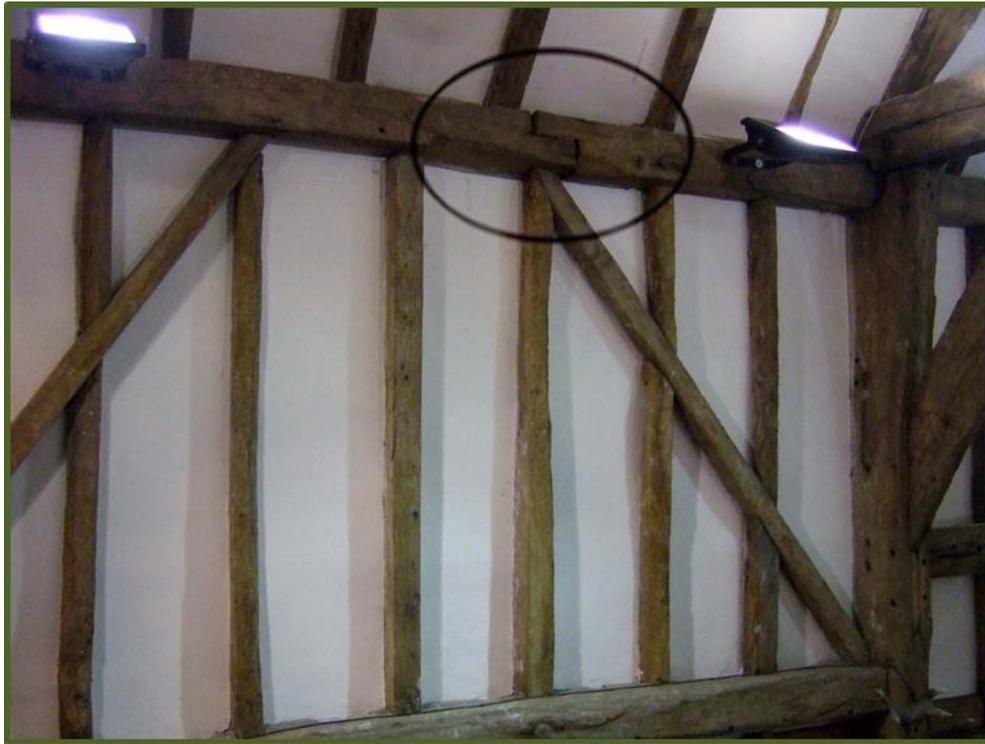
Where the wall was too long for a single beam to be used, scarfing (joining of two timbers) took place along the wall plate;

this example is from the Information Barn. Higher up, it is possible to see staggered purlins in the roof.

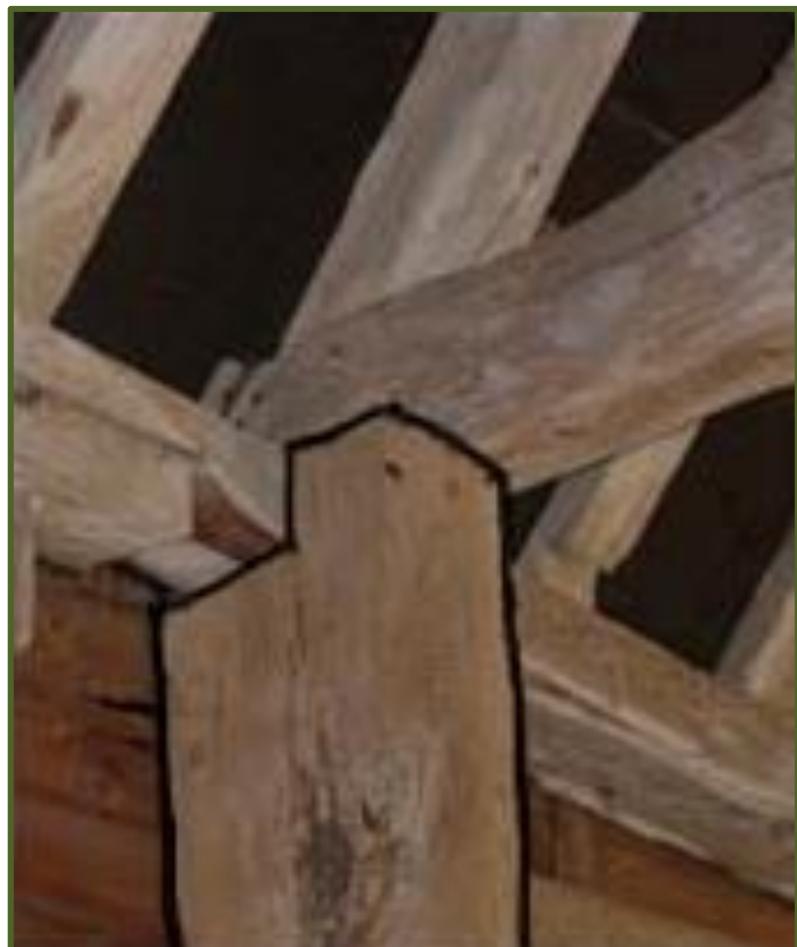
Another feature to be seen in the Information Barn is the use of root stocks or jowl posts in the corners. The tree trunks used as timbers here were fitted the wrong way up so that the post splayed out, creating enough bulk at the top for all the necessary joinery.

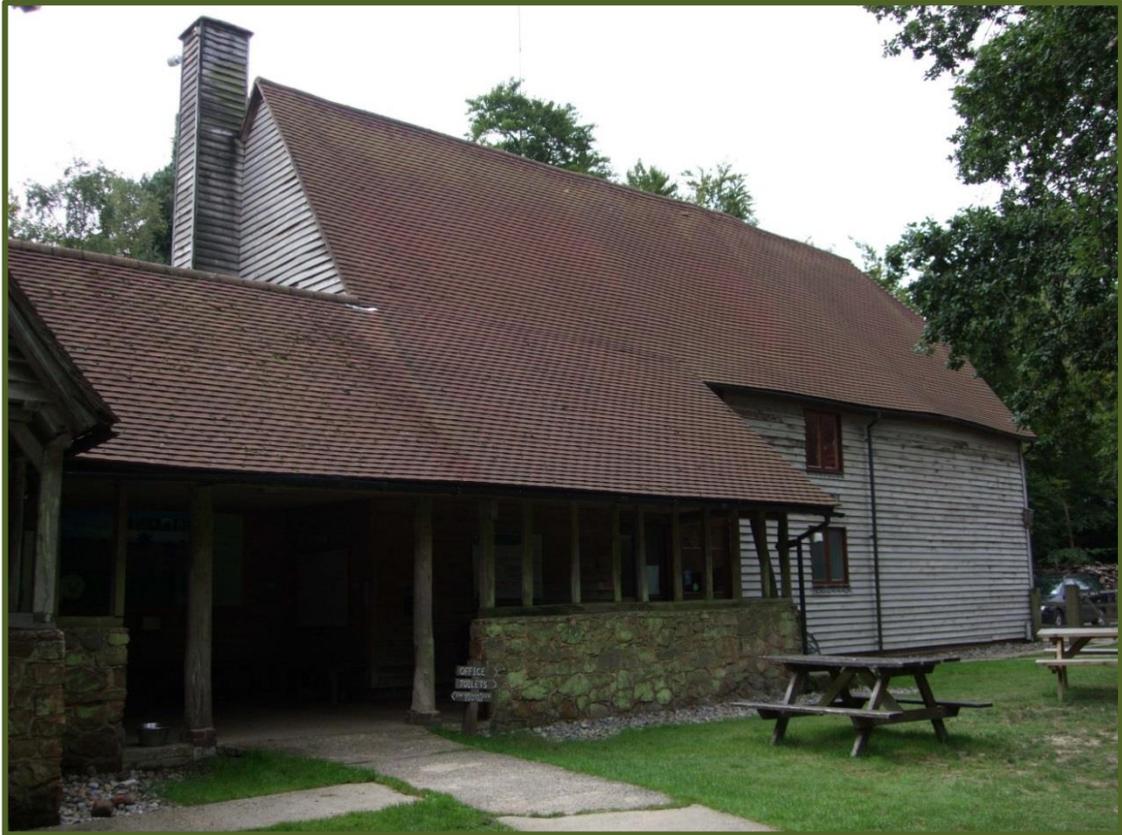
This barn is also authentic, although the covered way was added to link it to the Information Barn. The interior has been changed considerably in order to divide the area up into meeting rooms and office space.

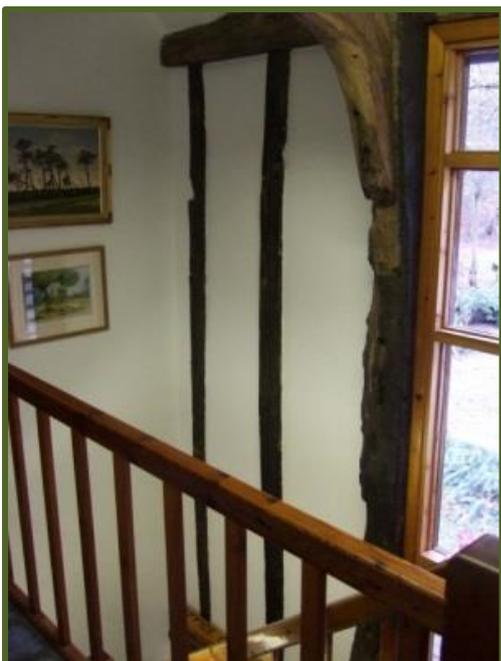
Despite supposedly being a Sussex barn, it has distinctly Wealden, even East Kentish features. One of these is the **close-studding** - upright timbers in the wall - which in this instance runs the whole height of the wall. This barn would have been a high status building, originally having at least four and probably five bays, which suggests it belonged to a farm of around 100 acres in size.

Although it is harder to see key features in this space because of the way it is used as office space, this is clearly an authentic barn. Dr Hughes was convinced that the **close-studding** was indicative of this barn coming from Kent originally.

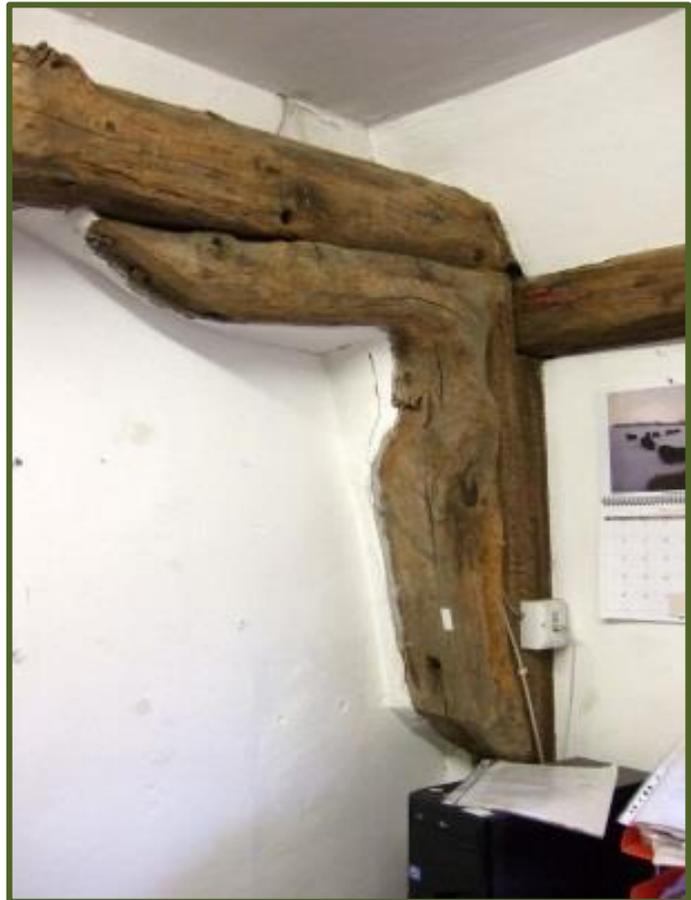
It also has some beautiful, naturally-shaped **knee braces**. These would have been put in to replace the original arched braces when the first floor offices were inserted. Timber-framed buildings often seem over-engineered to our eyes, but they were built to last. The Administration Barn probably dates from between 1650 and 1700.

This picture also shows diagonally placed wind braces running between the principle rafters and the purlins, a feature of the Administration Barn.

- **knee braces** - these are probably not original and would have replaced the carved braces put in at the time of building. Left in situ, these would have made the upper floor impossible to use as they would have cut across stairs and work areas.
- **wind-bracing** (curved struts between the rafters) which prevent the roof 'racking' – i.e. the rafters tipping out of vertical due to pressure from the wind.
- a **pegged apex** to the roof, a feature which suggests the barn was built before 1750.
- **clasped purlins**, i.e. the horizontal beams which support the rafters are held or 'clasped' by a collar beam – the piece of wood which crosses the roof space, making the cross-piece of an A shape to the rafters' uprights.
- **scarfing** - two pieces of wood joined together to make a long enough piece to run the length of the building.
